Andhra Pradesh State Road Transport Corporation  
Mechanical Engineering Department  
Office of the VC&MD, Bus Bhavan, Hyderabad-624

**CIRCULAR NO. 11/2009-MED, Date: 26-06-2009**

Sub : **MAINTENANCE** - Common failures of Tata BS-II vehicles - Certain instructions on preventive measures to be taken at Depots - Reg.

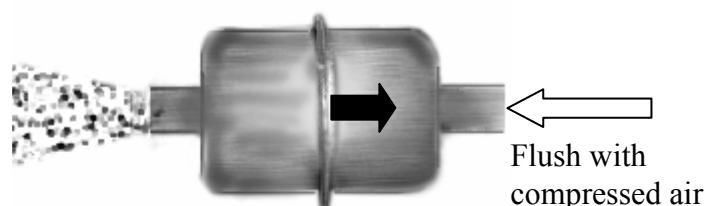
Cause & Effect	Remedy
<p>i) <b><u>Choking of Strainer (Baby filter)</u></b> : The choked Strainer causes trapping of air in the suction line sucked through the hand primer O’ring of the Fuel-Water Separator because of the vacuum developed between the strainer and Electrical Feed pump. This trapped air in the fuel system not only causes air lock trouble but also leads to failure of the pump due to hitting of Timer piston with the pump body at the time of starting due to its sudden movement because of trapped air.</p>	<ul style="list-style-type: none"> <li>➤ The Strainer (Baby filter) has to be cleaned <b>thoroughly during every Sch-III</b> maintenance to prevent its choking with dirt &amp; dust.</li> <li>➤ While cleaning the Strainer, the compressed air has to be applied in the reverse direction (opposite to the Arrow mark) so that the trapped dirt is ejected out from the wire mesh of the strainer.</li> <li>➤ The strainer has to be fitted only after ensuring that it is completely clear from the dirt. After cleaning, the strainer shall be fitted in such a manner that its ‘in’ and ‘out’ connections are correctly made as per the Arrow indication</li> </ul>

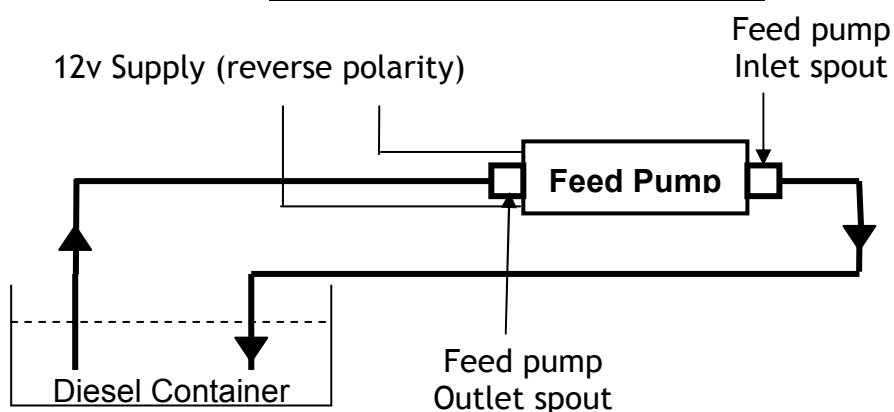
### Cleaning of Electrical Feed Pump

Cause & Effect	Remedy
<p><b>ii) Choking of Electric Feed Pump:</b> Sometimes, the Electric feed pump also gets choked with fine dirt due to which the delivery capacity of the pump falls down resulting in reduced fuel supply and air lock</p> <p>As the electrical feed pump works with 12 Electrical volts supply, the electrical connection to the Feed pump is tapped from 24 volts ignition supply line which is stepped down to 12 volts by a SERIES RESISTOR (Located in the left side chassis long member). Any attempt to bypass the resistor and connect the feed pump with 24 volts, the system will not function and the motor may burn out.</p>	<ul style="list-style-type: none"> <li>➤ The following checks have to be made during the scheduled maintenance to ensure that the pump is working satisfactorily. <ul style="list-style-type: none"> <li>i. Check the condition of Electric feed pump fuse during <b>every Sch.III.</b></li> <li>ii. Check the routing of wiring harness all along upto the feed pump during <b>every Sch.III.</b></li> <li>iii. Check complete engagement of all Electrical sockets of the wiring harness every <b>Sch.III.</b></li> <li>iv. Check the battery voltage/ specific gravity during every <b>Sch.II &amp; III.</b></li> <li>v. Check the correct functioning of Feed pump during <b>every alternate Sch.IV.</b> If the flow rate is found less than 2 lit per minute, clean the electric feed pump by giving reverse polarity so that the sediments are flushed out from the pump inlet.</li> </ul> </li> <li>➤ The Resistor shall be checked periodically for its output voltage. Voltage higher than 12 volts may lead to failure of Electric Feed pump.</li> <li>➤ The Electrical Feed Pump gets supply and starts working as soon as the Ignition Key gets inserted into the Ignition switch. Hence, for getting improved life of the Feed Pump, Ignition Key should be removed from the switch as soon as the Engine was stopped</li> </ul>

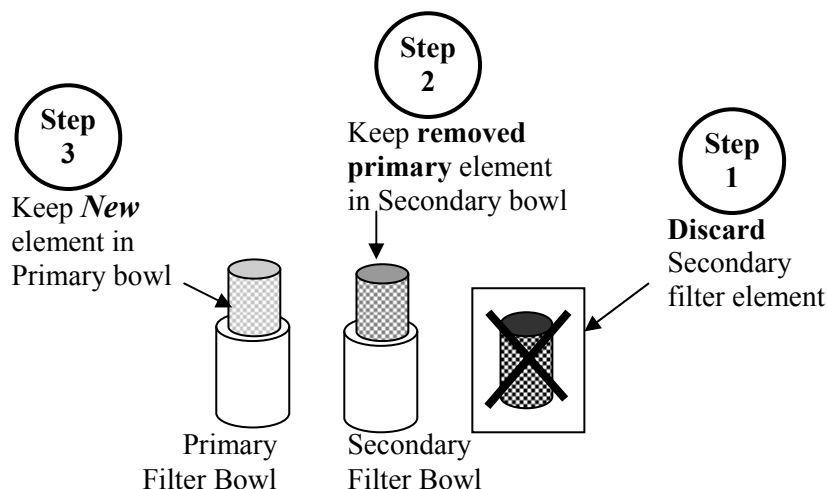
Cause & Effect	Remedy
<p><b>iii) Choking of Fuel filters:</b> Since the life &amp; efficiency of the Fuel pump greatly depend on the quality of fuel and its filtration level, the condition of Fuel filters plays very important role in the fuel system.</p> <p>As the filtration efficiency of the filter elements falls down after certain period owing to various reasons, there is scope for reduction in the fuel rate causing Air lock problems</p>	<ul style="list-style-type: none"> <li>➤ In Tata BS-II vehicles, both primary and secondary fuel filters are provided with Star type Paper elements for better filtration.</li> <li>➤ The filter elements have to be replaced strictly as per the <b>prescribed periodicity of 18,000 kms for both the filters.</b></li> <li>➤ While changing the filter elements, it must be ensured that the periodicity of <b>primary &amp; secondary filters changes is staggered such that both elements are not replaced at a time.</b></li> <li>➤ The fuel system has to be bleed properly while changing the fuel filters to avoid entry of air into the fuel pump which otherwise would cause damage to the pump body and timer piston.</li> </ul>

**FILTER CHANGE PROCEDURE AT EVERY 9,000 Kms:** The following system shall be adopted for changing Fuel filter elements.

1. Initially at 9,000 kms, remove the secondary filter element and discard it.
2. Take out the fuel filter element from the primary filter bowl and fix it in the secondary filter bowl.
3. Put a new filter element in the Primary filter bowl.
4. Adopt the same procedure at every 9,000 kms thereafter.

Thus at every 9,000 kms only element needs to be replaced and hence only one filter element shall be drawn from the Stores. The above filter change periodicity shall be incorporated in the VEMAS module for obtaining the advance programme.

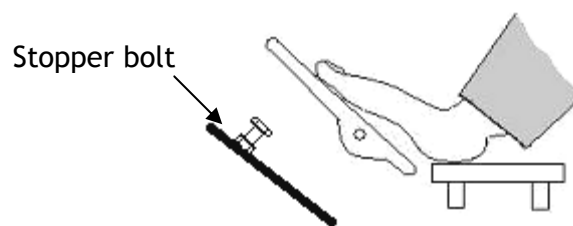
- 3.02 **Stopper Bolt for Accelerator Pedal Travel** : In many cases, the Stopper bolt for Accelerator pedal is found missing in the vehicles. If the Stopper bolt is not provided, the pedal travel movement will exceed the normal travel which leads to overloading of FIP lever, lever shaft and guide bush resulting in premature failure and diesel leakage from the guide bush. The height of the Stopper bolt shall be adjusted in such a way that it touches the accelerator pedal just before reaching the maximum travel by the pump lever.

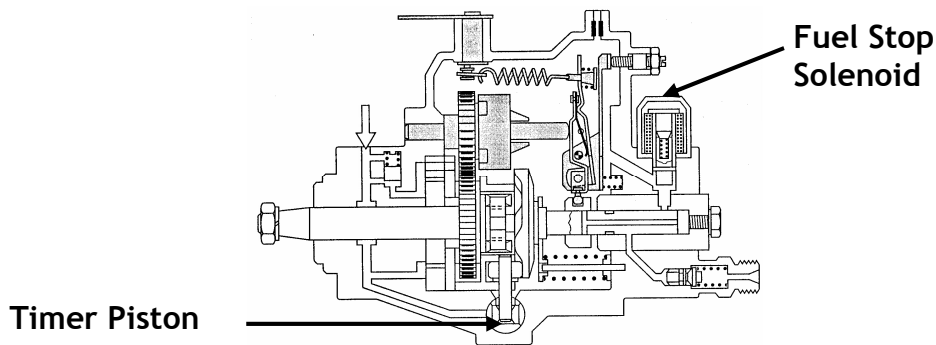
- 3.05 **Tampering the Spring & Nipple in the FIP solenoid system** - At some depots, the spring and Nipple in the Fuel stop solenoid are being removed. In such cases, the Fuel available in the line between the Electrical feed pump and the FIP gets sucked into the FIP even though the engine is stopped. This again will cause a low pressure in the fuel line whereby air is sucked into the system leading to the failures.

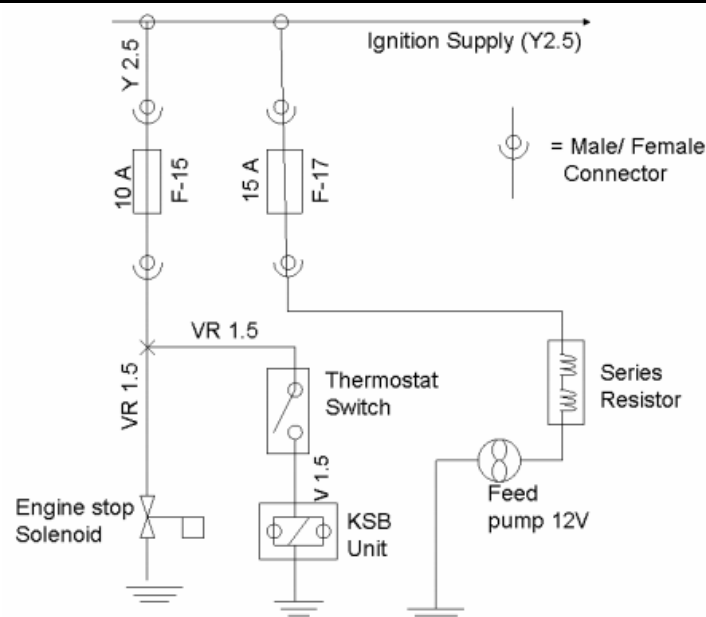
**CIRCUIT DIAGRAM FOR ENGINE STOP SOLENOID, KSB & FEED PUMP**

3.07 **Fitment of correct rated Fuses for Engine Stop Solenoid, KSB & Feed pump** : In order to protect the wiring harness from damage in case of short circuit and overloads, fuses of glass cartridges as per IS 2577 are provided in a transparent fuse box. The particulars of consumers served by each fuse are printed on the fuse box. Precautions shall necessarily be taken to replace the fuses with fuse cartridges of designated rating only. Never attempt to tamper the fuses and never use over rated fuses. Tampered fuses will not protect the wiring in the event of overloading/ short circuit. The ampere ratings of the fuses are given on the fuse box cover. The fuses of different ratings are easily available in the market and the cost of these fuses is very less. The fuse links can be identified for amperage by colour codes; Light brown-5 Amps, Red-10 Amps, Blue-15 Amps and Yellow-20 Amps.

Ensure that the details of fuses printed on the fuse box cover are clearly visible so that it will be easy to check the respective fuse in the case of fault in the electrical system. Proper care shall be taken while painting to avoid paint marks on the fuse box cover.
