Andhra Pradesh State Road Transport Corporation
Office of the Managing Director, Bus Bhavan, Hyderabad - 500 624.

CIRCULAR No. 22/2010 - MED, Dt 21.08.2010

SUB: **MAINTENANCE** - Proper maintenance of Brake System - Provision of Low Air Pressure Warning system for all vehicles - Certain instructions issued - Reg.

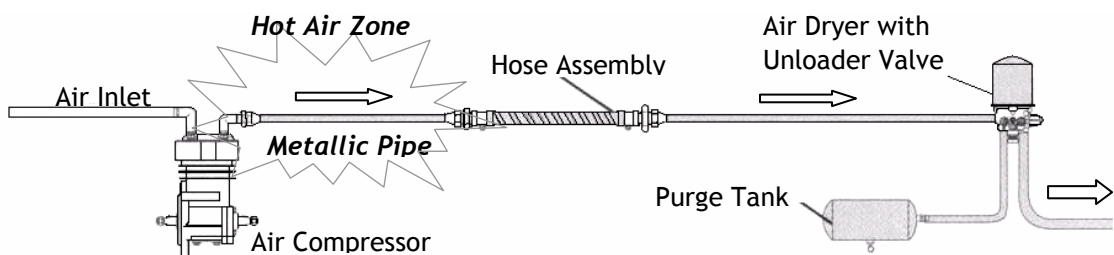
1. The original **metallic pipe** between the Air Compressor Outlet and Compressor rubber hose was replaced with a **hose pipe** (available in FC kit) which was **not supposed to be fitted in place of metallic pipe**. Since, the air temperature in the Air Compressor outlet is too high for a hose pipe to withstand; the hose pipe has failed enroute, thereby disconnecting the Air compressor to the rest of the system.

- Proper **clamping shall be provided to all Brake pipes** to avoid breakage due to vibrations and rubbing with other objects.
- Proper care shall be taken **to avoid damage to the Polyamide pipes** while doing welding works.
- The guidelines issued vide **Circular No 20/2007-MED** on maintenance of brake system shall be implemented scrupulously
- **Under no circumstance, the rubber hose pipes shall be fitted in place of Metallic pipes provided by the Vehicle Manufacturers**
- The **Low Pressure warning system shall always be kept under working condition**. The defective Low Air Pressure Switches, indicators & Beepers shall be replaced immediately. The DB Valves supplied by Workshops shall invariably be fitted with Low Pressure switches which are in proper working condition.

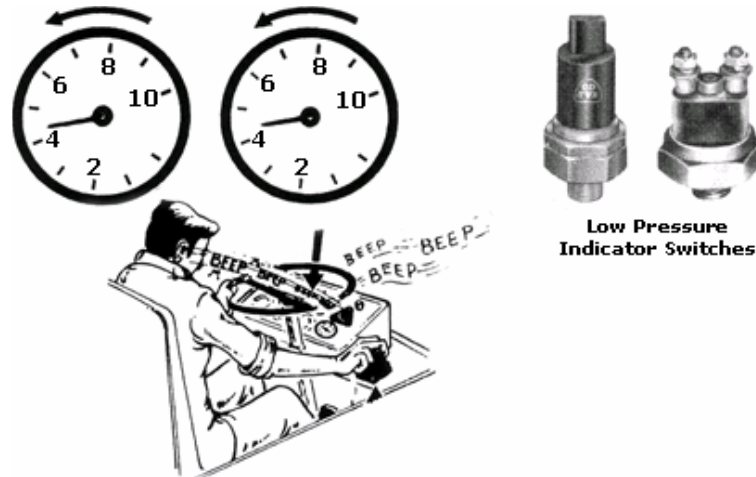
2. The “**Low Pressure Warning system**” was not functioning. There were no connections between the **Low Pressure Switches** of DB Valve and the **LOW AIR PRESSURE WARNING BEEPER** near the dashboard. As such, the beeper failed to warn the driver about the low air pressure when the system pressure fell down to 4.9 kg/cm^2

The **Dy.Chief Mechanical Engineers** are advised to **conduct census on availability & working condition of the Low Pressure Warning systems** on all the vehicles and submit the depot-wise requirement to the Zonal Stores for procurement and supply of all necessary spare parts to keep the Low Pressure Warning system in working condition on all vehicles.

The **Works Manager** shall **ensure that the overhauled DB Valves be fitted with Low Pressure Switches & Stop Light Switches** without fail.
