Andhra Pradesh State Road Transport Corporation

No: OP3/462(01)/2018-MED

CIRCULAR No. 08/2018 -MED, Dated.05.06.2018.

Sub: **UPKEEP**: Timely replacement of cracked front wind screen glasses - Instructions Issued - Reg.

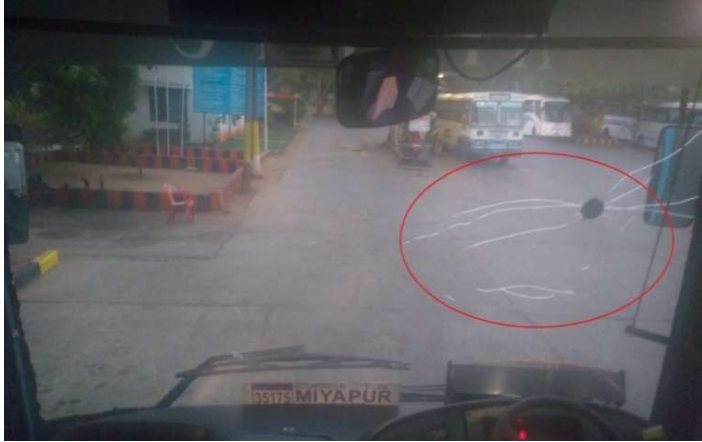
Fig. 1 – Cracks in front of Driver

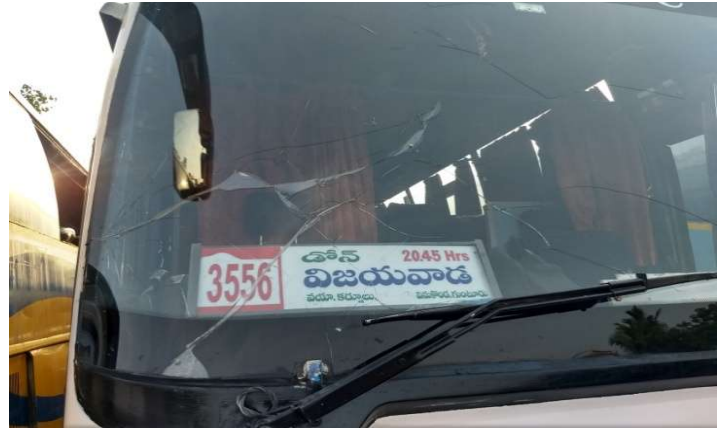
Fig.2- Multiple cracks and film separation

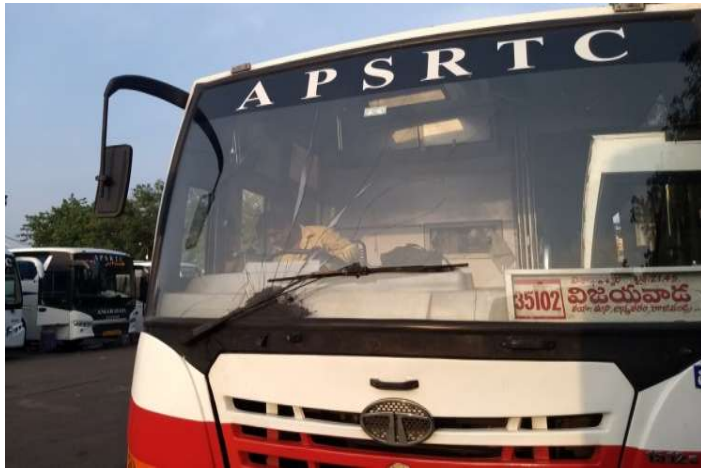
Fig.3 - Multiple cracks in front of driver

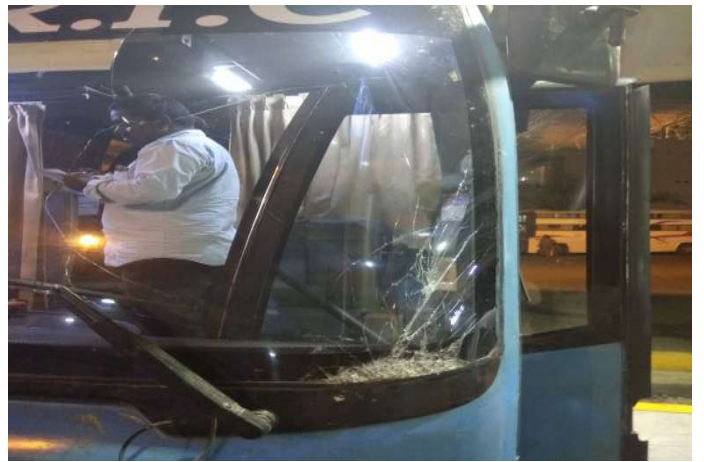
Fig.4- Ugly appearance
