ANDHRA PRADESH STATE ROAD TRANSPORT CORPORATION
Mechanical Engineering Department

CIRCULAR No. 12 /2021-MED Dt.10.11.2021

Sub: MAINTENANCE: Special drive from 12.11.2021 to 18.11.2021 on Proper fitment and tightening of wheel nuts & bolts and proper setting of wheel hub play - Instructions issued- Reg.

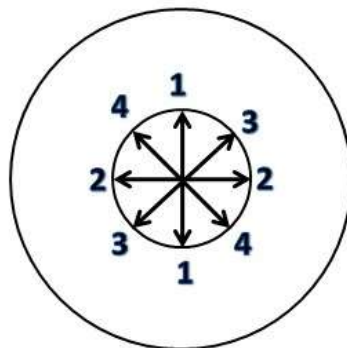
- g). Wheel nuts should be tightened in pairs i.e., "opposite to each other" as shown in the figure.

- f). After tyre is mounted onto the hub, all the wheel nuts must be tightened fully in wheel jacked up position only, by providing support to the wheel disc in opposite direction of tightening, to prevent its rotation and to ensure full tightening.
