## Andhra Pradesh State Road Transport Corporation Office of the Managing Director, Bus Bhavan, Hyderabad - 500 0624.

## CIRCULAR No. 21/2009-MED, Dt 11.09.2009

Sub : <u>MAINTENANCE</u> - Improper connections to the DB Valve at the time of replacement - Certain instructions issued - Reg.

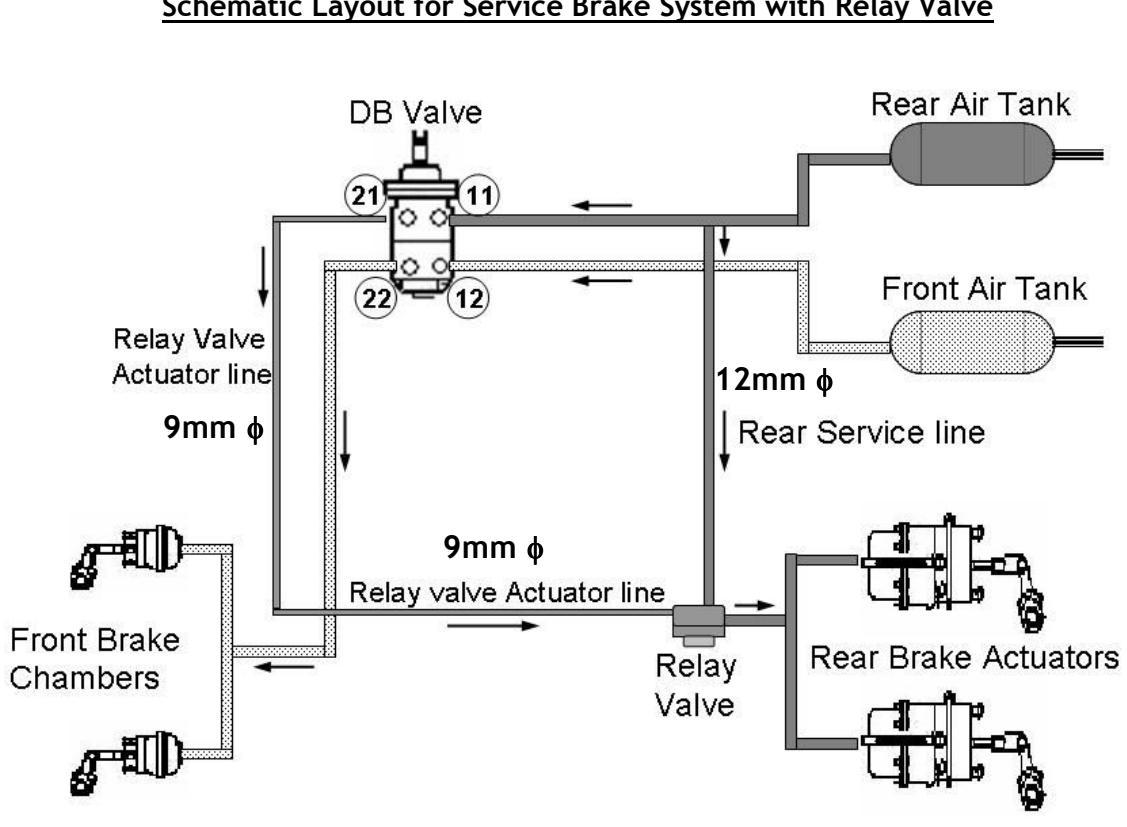
## Schematic Layout for Service Brake System with Relay Valve

During the recent inspection of the Depots by the Service Engineers of **M/S WABCO-TVS**, it was observed in latest BS-II vehicles (with Relay Valves) that the air pressure drop is observed only in one gauge instead of two. This indicates that for both service brakes (front & rear), the air is drawn from single tank. On further investigation, it is observed that the connections at the DB valve inlet Port No.11 and 12 are interchanged due to ignorance at the time of replacing the DB valve leading to heavy consumption of air from only one reservoir. The correct layout of Service Brake system with Relay valve is shown hereunder.

- The Front Service Brakes are actuated by the compressed air drawn from Front Service reservoir through Port No. 12 and 22 of DB Valve.
- While there is no change in the Front Brake system, the Rear Brake Actuation is different in this model compared to the earlier models which are not fitted with Relay valve.

- Unlike Front Service Brakes, the Rear Service Brakes are actuated through a Relay Valve by drawing the compressed air directly from the Rear Service Reservoir through a pipe line of 12 mm dia. The relay valve is actuated by a control line of size 9 mm dia connected from Port No.21 of DB valve to the Relay Valve.

- On pressing the Brake pedal, the compressed air at Port No.11 of DB valve goes to the Relay valve through Port No.21 via control line to actuate the relay valve. The Relay valve in turn allows the Compressed air from the Rear Service Reservoir to enter into the Rear Brake chambers.

- In case the pipe line connections at DB valve are interchanged (among Port No. 11 and 12) by mistake, The Service lines for both Front & Rear Brake chambers will be connected to a single Service Reservoir i.e Rear tank only and the Front Service Reservoir supplies air to the Relay control line instead of supplying air to the front Brake circuit. Thus the consumption of air will be more in only one tank. This is highly dangerous and may result in Brake failure in the event of any pressure loss in the Rear Service Reservoir which is supplying air to both Front & Rear Brake Chambers.

Therefore you are advised to instruct the Depot Managers and Maintenance Incharges under your jurisdiction to inspect all the vehicles at their Depots and ensure proper connections at DB valve.
